Fiat Auto

ORDER 4449

Model: Fiat STILO 1.8, 2.4 Selespeed, JTD
- engine cooling radiator fan ECU -

RECALL CAMPAIGN 4449

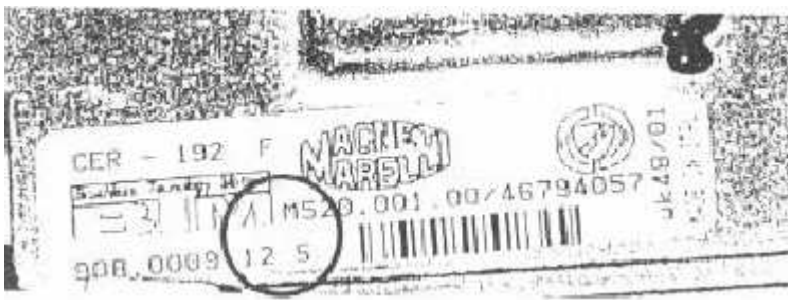
NOT COMPLIANT: WITH "S" (Ref. A)

- A. If the ECU is labelled by Magneti Marelli and the numeric code is followed by letter "S", run a diagnostic ECU test with EXAMINER following the procedure described in the TEST WITH EXAMINER section to identifying the non compliant ECUs. Replace the ECU if it is not compliant as described in the INTERVENTION section.
- B. If the ECU does not carry the Magnetic Marelli trademark, the vehicle is OK.
- C. If the ECU carries the Magnetic Marelli trademark and that last letter of the code is not "S", the vehicle is OK.
- D. If there is a yellow or silver flag on the ECU earth wire near the negative battery terminal fastening eyebolt, the vehicle is OK.
- E. If there is a spot of green or yellow paint on the ECU cover, the vehicle is OK.

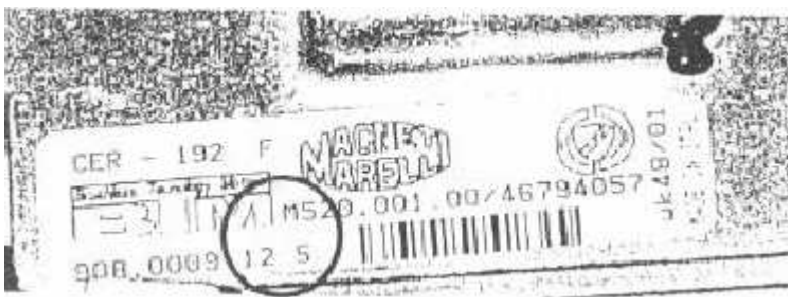
COMPLIANT (Ref. B)
