P. 697/07

CAMPAIGN 5264 – SERVICE CAMPAIGN

**Models FIAT Linea, Idea, 500, Palio, Albea, GPunto with Fire 1.4 8V – 1.2 8V EVO
engines
- timing sensor**

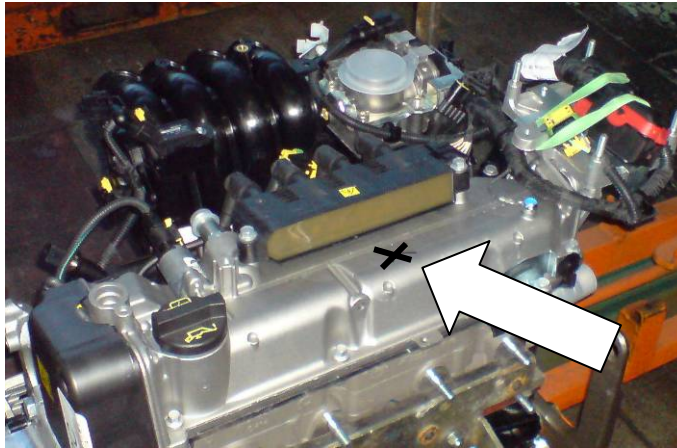
Check for a cross on the cam cover

- The vehicle is compliant if this is present.
- Fit the air filter casing assembly.
 - If not present, proceed as follows:
 - Disconnect the battery negative terminal.
 - Remove the injection control unit and mount as described in op. 1056 B 87.
 - Unscrew the screw (arrowed) and remove timing sensor 1.

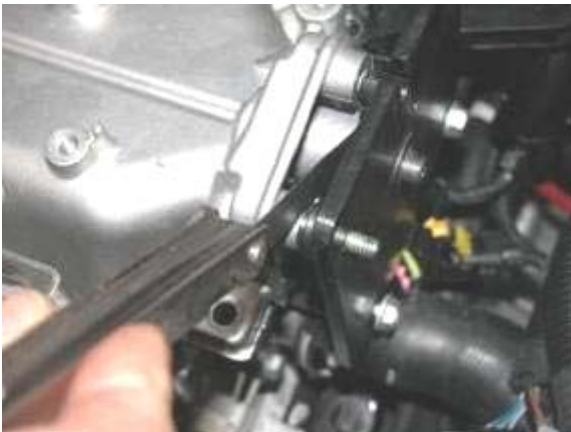
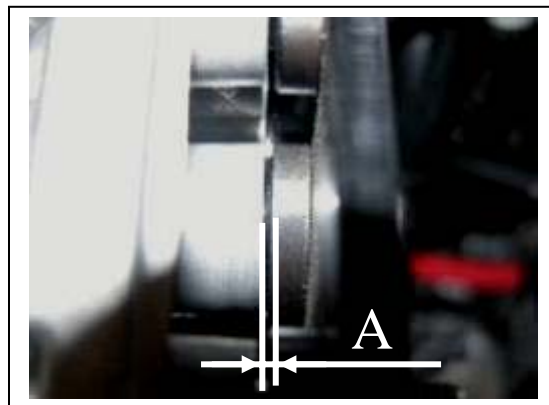
- Check gap “A” between the tool and the timing sensor boss contact surface.

- If the boss contact surface is in contact with the tool, the vehicle is compliant.

- If the boss contact surface is not in contact with the tool, the vehicle is not compliant. In this case, proceed as follows:

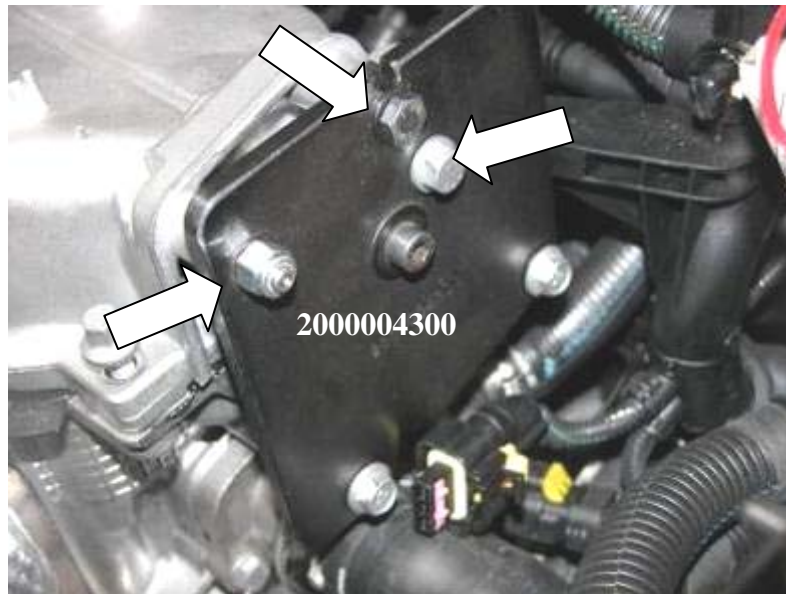
- Screw in the bolts/nut (arrowed) securing part 2000004300 to the cam cover slightly and then tighten to bring the cam cover into contact with the tool surface.

NOTE: screw in slightly to prevent the slip between the cam cover and cylinder head from damaging the gasket.

- Tighten the cam cover and wiring bracket bolts to a torque of 9 Nm.

- Tighten the timing belt cover bolts to a torque of 9 Nm.

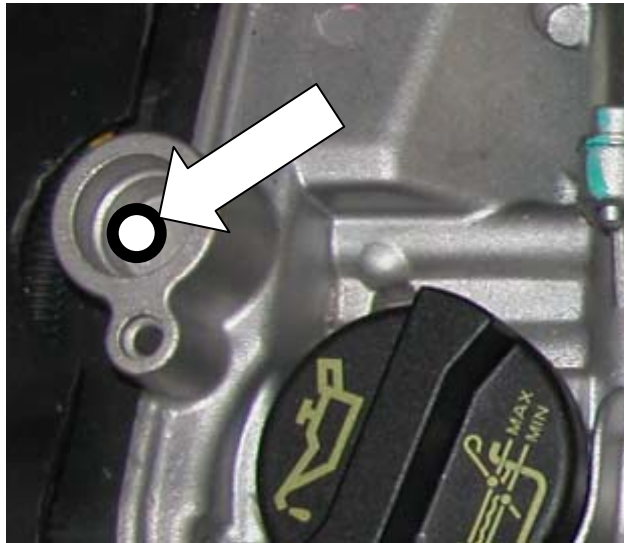
White paint spot on the cam cover in the unused boss (arrowed).

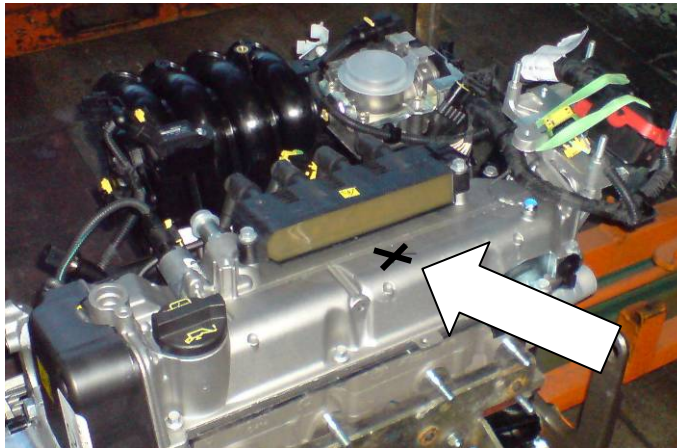
Check for a cross on the cam cover

- The vehicle is compliant if this is present.
- Fit the air filter casing assembly.
 - If not present, proceed as follows:
 - Disconnect the battery negative terminal.
 - Remove the injection control unit and mount as described in op. 1056 B 87.
 - Unscrew the screw (arrowed) and remove timing sensor 1.

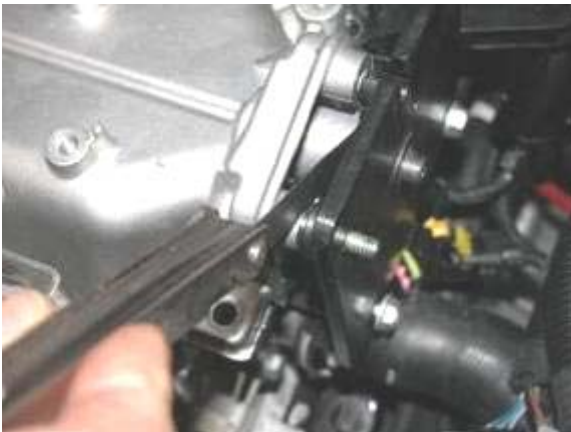
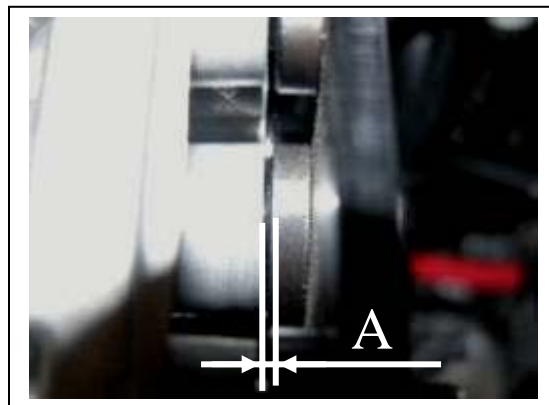
- Check gap “A” between the tool and the timing sensor boss contact surface.

- If the boss contact surface is in contact with the tool, the vehicle is compliant.

- If the boss contact surface is not in contact with the tool, the vehicle is not compliant. In this case, proceed as follows:

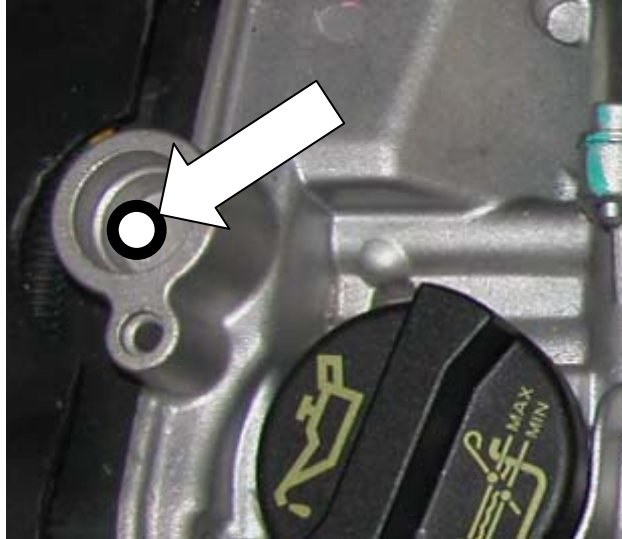
White paint spot on the cam cover in the unused boss (arrowed).

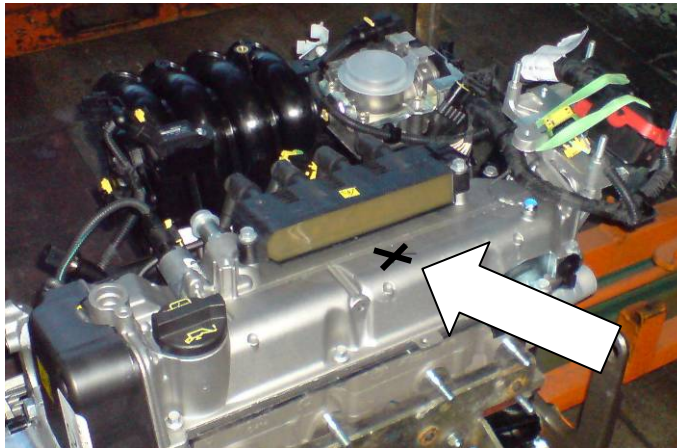
Check for a cross on the cam cover

- The vehicle is compliant if this is present.
- Fit the air filter casing assembly.
 - If not present, proceed as follows:
 - Disconnect the battery negative terminal.
 - Remove the injection control unit and mount as described in op. 1056 B 87.
 - Unscrew the screw (arrowed) and remove timing sensor 1.

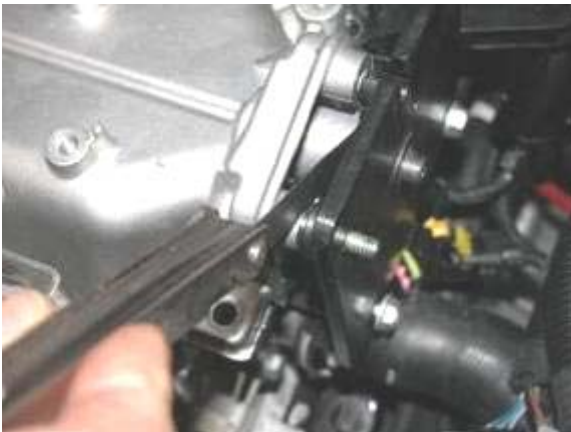
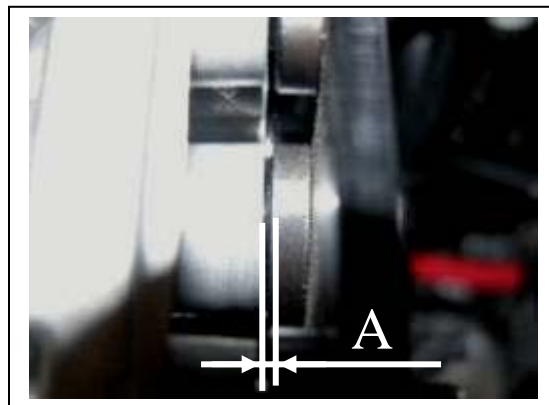
- Check gap “A” between the tool and the timing sensor boss contact surface.

- If the boss contact surface is in contact with the tool, the vehicle is compliant.

- If the boss contact surface is not in contact with the tool, the vehicle is not compliant. In this case, proceed as follows:

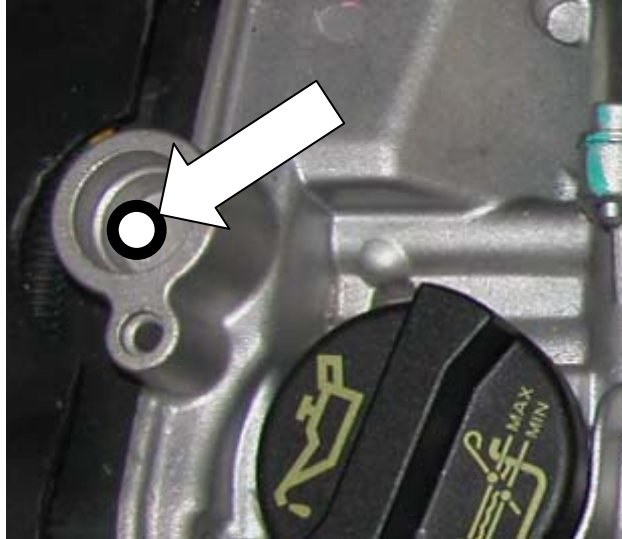
White paint spot on the cam cover in the unused boss (arrowed).

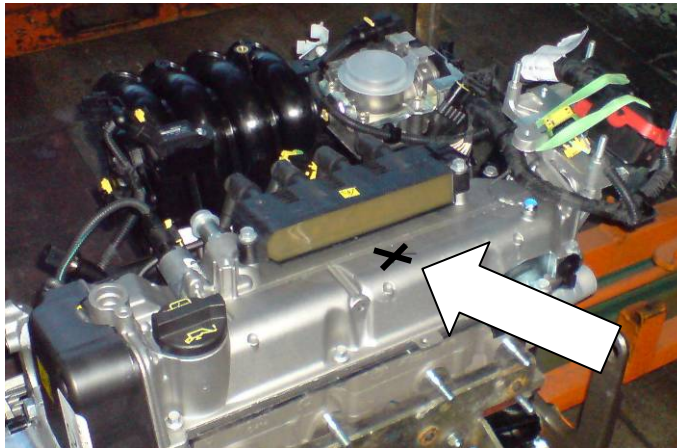
Check for a cross on the cam cover

- The vehicle is compliant if this is present.
- Fit the air filter casing assembly.
 - If not present, proceed as follows:
 - Disconnect the battery negative terminal.
 - Remove the injection control unit and mount as described in op. 1056 B 87.
 - Unscrew the screw (arrowed) and remove timing sensor 1.

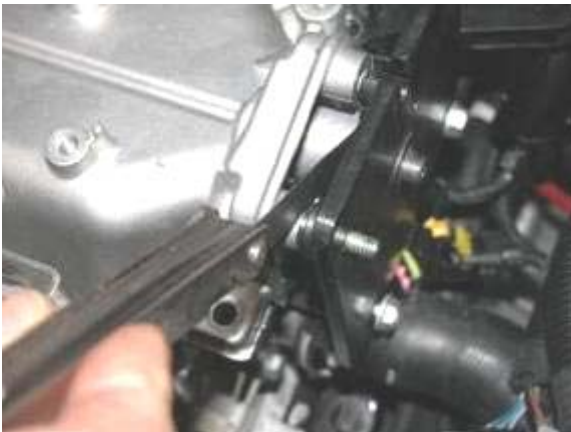
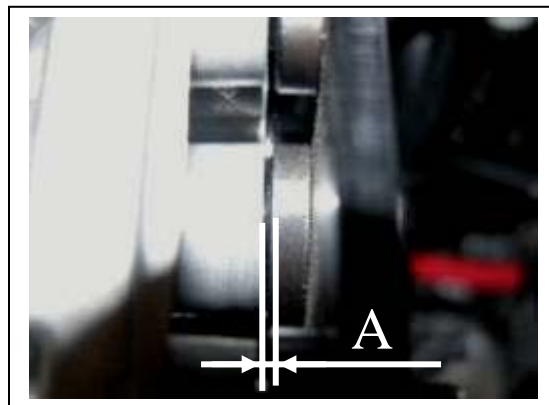
- Check gap “A” between the tool and the timing sensor boss contact surface.

- If the boss contact surface is in contact with the tool, the vehicle is compliant.

- If the boss contact surface is not in contact with the tool, the vehicle is not compliant. In this case, proceed as follows:

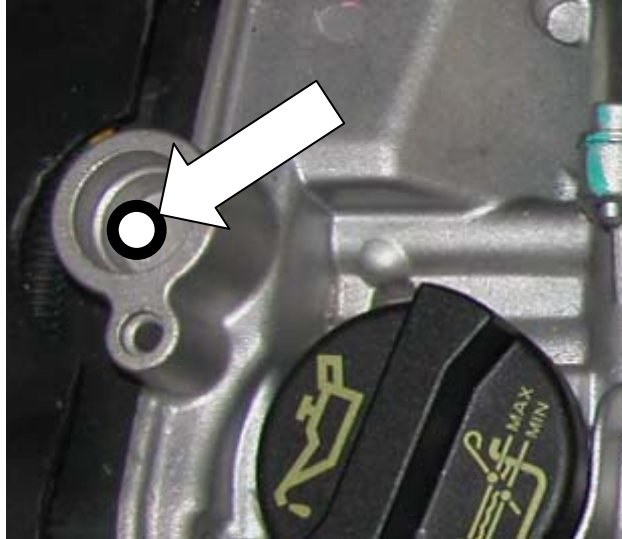
White paint spot on the cam cover in the unused boss (arrowed).

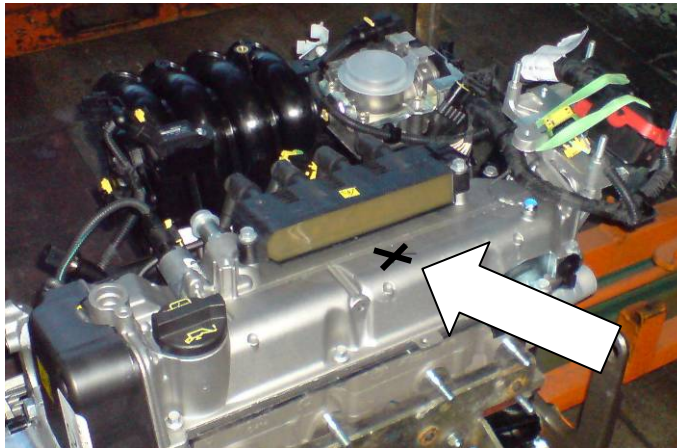
Check for a cross on the cam cover

- The vehicle is compliant if this is present.
- Fit the air filter casing assembly.
 - If not present, proceed as follows:
 - Disconnect the battery negative terminal.
 - Remove the injection control unit and mount as described in op. 1056 B 87.
 - Unscrew the screw (arrowed) and remove timing sensor 1.

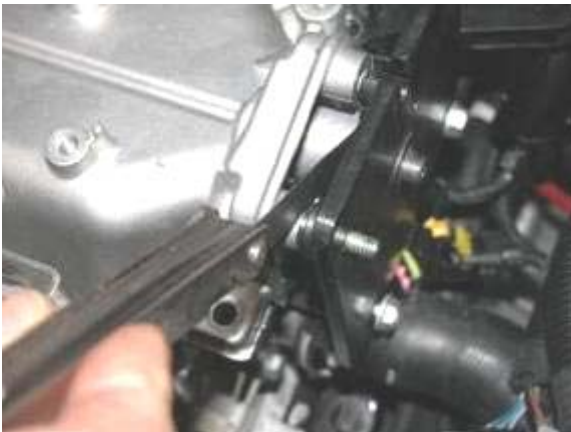
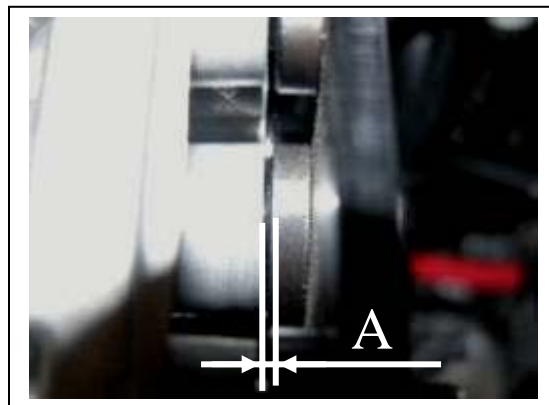
- Check gap “A” between the tool and the timing sensor boss contact surface.

- If the boss contact surface is in contact with the tool, the vehicle is compliant.

- If the boss contact surface is not in contact with the tool, the vehicle is not compliant. In this case, proceed as follows:

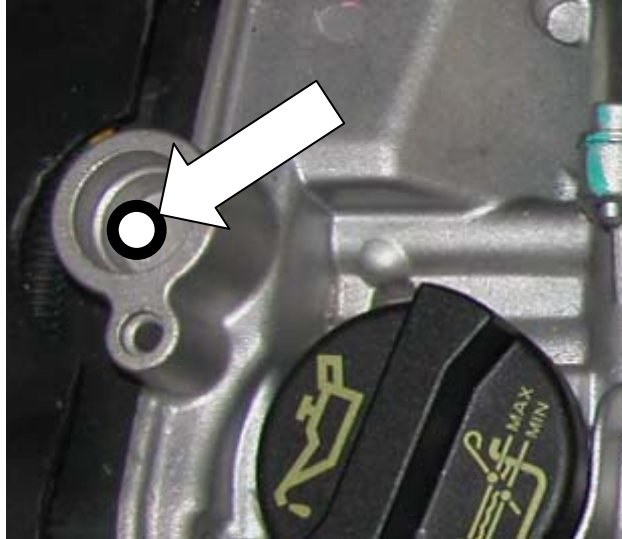
White paint spot on the cam cover in the unused boss (arrowed).

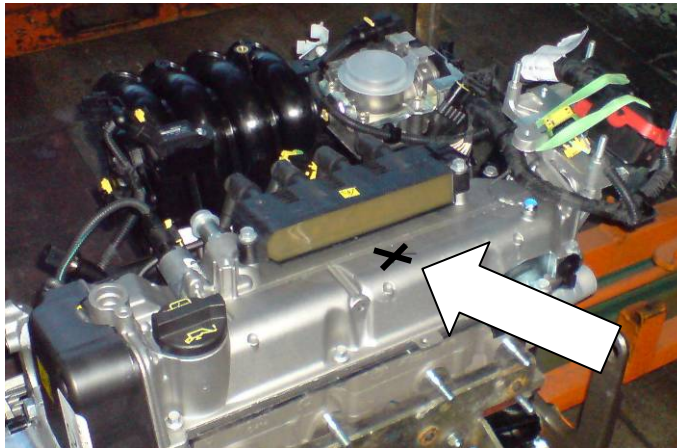
Check for a cross on the cam cover

- The vehicle is compliant if this is present.
- Fit the air filter casing assembly.
 - If not present, proceed as follows:
 - Disconnect the battery negative terminal.
 - Remove the injection control unit and mount as described in op. 1056 B 87.
 - Unscrew the screw (arrowed) and remove timing sensor 1.

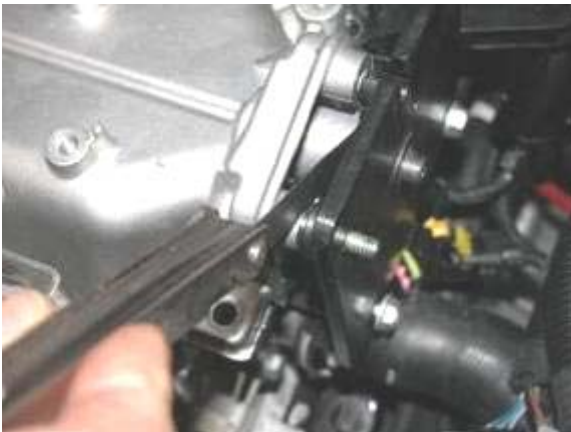
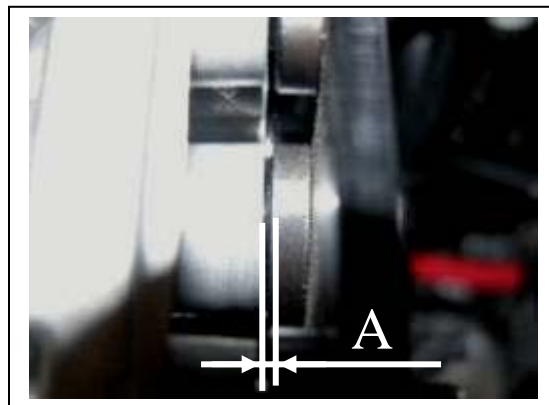
- Check gap “A” between the tool and the timing sensor boss contact surface.

- If the boss contact surface is in contact with the tool, the vehicle is compliant.

- If the boss contact surface is not in contact with the tool, the vehicle is not compliant. In this case, proceed as follows:

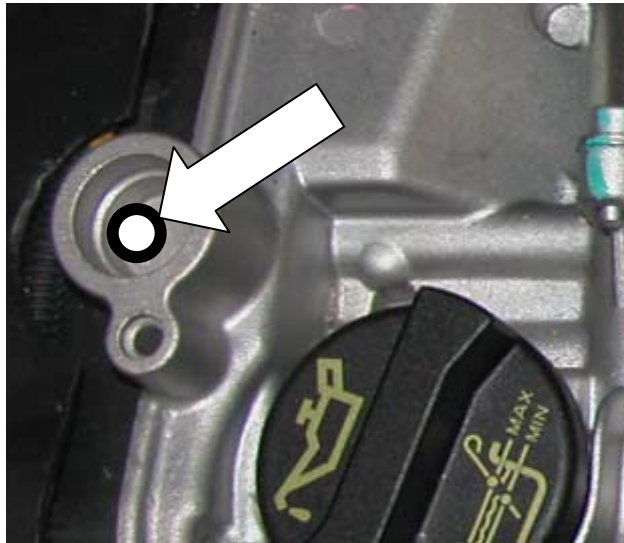
White paint spot on the cam cover in the unused boss (arrowed).
