Fiat Auto

ORDER 4449

Model: Fiat STILO 1.8, 2.4 Selespeed, JTD
- engine cooling radiator fan ECU -

RECALL CAMPAIGN 4449

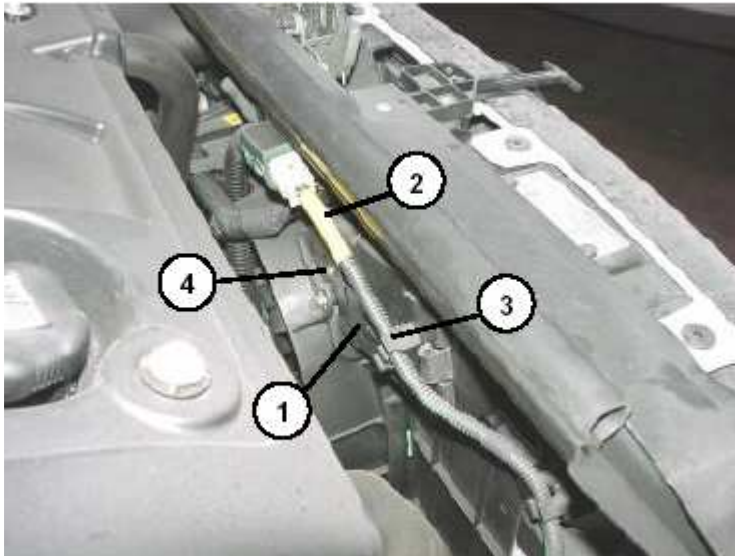
- A. If the ECU is labelled by Magneti Marelli and the numeric code is followed by letter "S", run a diagnostic ECU test with EXAMINER following the procedure described in the TEST WITH EXAMINER section to identifying the non compliant ECUs. Replace the ECU if it is not compliant as described in the INTERVENTION section.
- B. If the ECU does not carry the Magnetic Marelli trademark, the vehicle is OK.
- C. If the ECU carries the Magnetic Marelli trademark and that last letter of the code is not "S", the vehicle is OK.
- D. If there is a yellow or silver flag on the ECU earth wire near the negative battery terminal fastening eyebolt, the vehicle is OK.
- E. If there is a spot of green or yellow paint on the ECU cover, the vehicle is OK.

NOT COMPLIANT: WITH "S" (Ref. A)

If voltage is higher than or equal to 0.045 V, replace the ECU as shown in
INTERVENTION section (disconnect the negative battery terminal before replacing).
