P. 697/07

CAMPAIGN 5264 – SERVICE CAMPAIGN

**Models FIAT Linea, Idea, 500, Palio, Albea, GPunto with Fire 1.4 8V – 1.2 8V EVO
engines
- timing sensor**

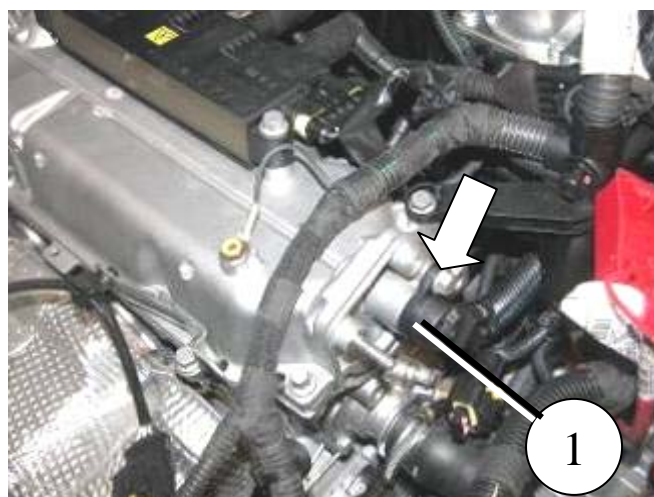
- The vehicle is compliant if this is present.
- Fit the air filter casing assembly.
 - If not present, proceed as follows:
 - Disconnect the battery negative terminal.
 - Remove the injection control unit and mount as described in op. 1056 B 87.
 - Unscrew the screw (arrowed) and remove timing sensor 1.

-Position tool 2 part. 2000004300.

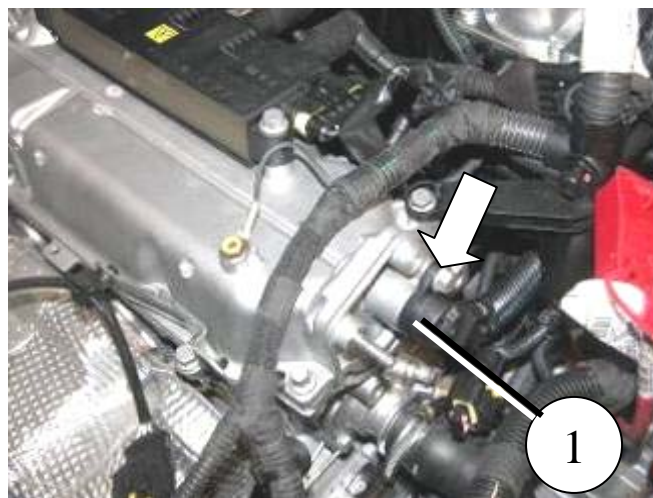
- The vehicle is compliant if this is present.
- Fit the air filter casing assembly.
 - If not present, proceed as follows:
 - Disconnect the battery negative terminal.
 - Remove the injection control unit and mount as described in op. 1056 B 87.
 - Unscrew the screw (arrowed) and remove timing sensor 1.

-Position tool 2 part. 2000004300.

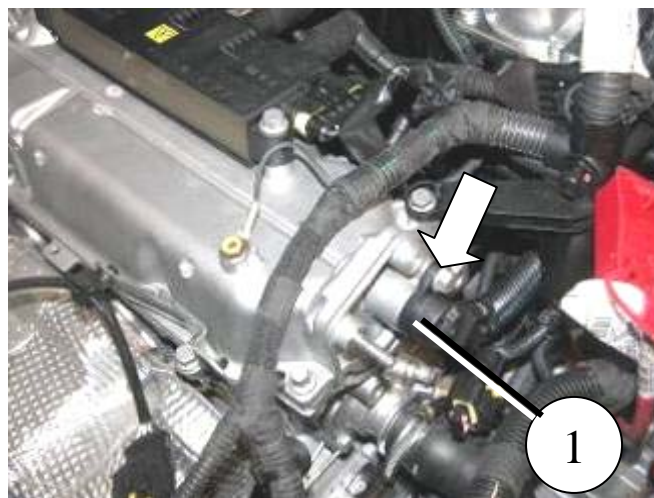
- The vehicle is compliant if this is present.
- Fit the air filter casing assembly.
 - If not present, proceed as follows:
 - Disconnect the battery negative terminal.
 - Remove the injection control unit and mount as described in op. 1056 B 87.
 - Unscrew the screw (arrowed) and remove timing sensor 1.

-Position tool 2 part. 2000004300.
